**DEPARTMENT OF TRANSPORTATION**

Contract #: 04-0120F4Cty: SF/ALA Rte: 80 PM: 13.2/13.9File #: 69.28**WELDING INSPECTION REPORT****Resident Engineer:**Siegenthaler, Peter**Address:** 333 Burma Road**City:** Oakland, CA 94607**Report No:** WIR-022733**Date Inspected:** 17-Apr-2011**Project Name:** SAS Superstructure**OSM Arrival Time:** 700**Prime Contractor:** American Bridge/Fluor Enterprises, a JV**OSM Departure Time:** 1900**Contractor:** Zhenhua Port Machinery Company, Ltd (ZPMC), Changxing Island **Location:** Shanghai, China**CWI Name:** Liu Hua Jie.**CWI Present:** Yes No**Inspected CWI report:** Yes No N/A**Rod Oven in Use:** Yes No N/A**Electrode to specification:** Yes No N/A**Weld Procedures Followed:** Yes No N/A**Qualified Welders:** Yes No N/A**Verified Joint Fit-up:** Yes No N/A**Approved Drawings:** Yes No N/A**Approved WPS:** Yes No N/A**Delayed / Cancelled:** Yes No N/A**Bridge No:** 34-0006**Component:** OBG components.**Summary of Items Observed:**

# WELDING INSPECTION REPORT

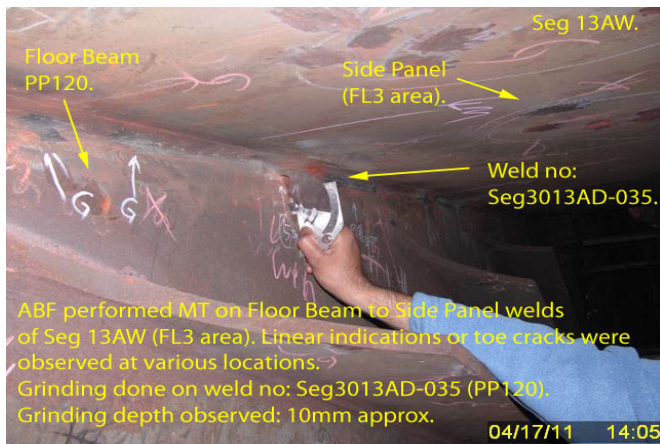
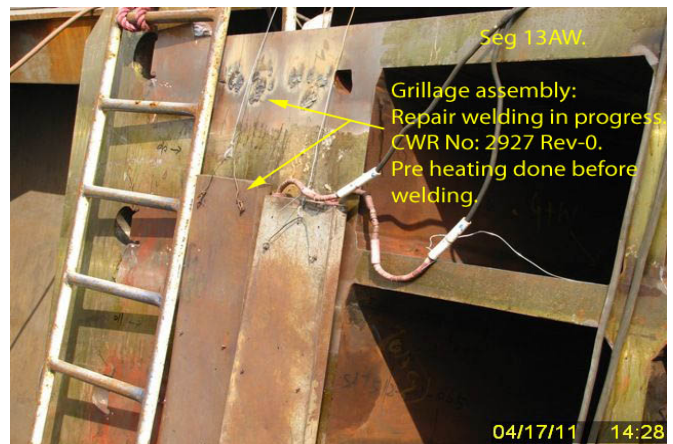
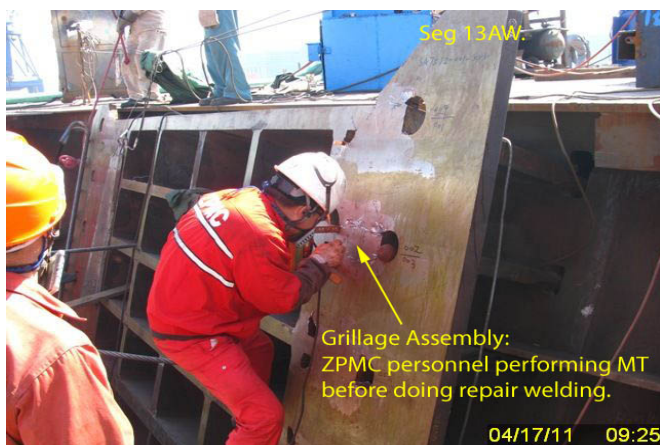
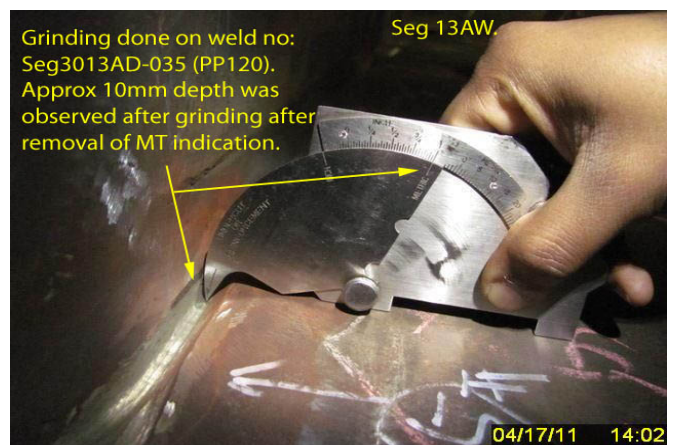
Repair welding on the machined surfaces of the Grillage assembly after excavating the linear indications observed after performing Magnetic Particle testing (MT). The welder is identified as 047864 and was observed welding in the 2G position. Welding process was identified as Shielded Metal Arc Welding (SMAW). ZPMC Quality Control (QC) was identified as Shen Jian Bo. The welding variables recorded by this QC appeared to comply with welding procedure specification (WPS): 345-SMAW-2G(2F)-FCM-Repair. Repair welding was done as per Critical Welding Repair Report (CWR): 2927 Rev-0. MT was observed to be done before performing repair welding. See attached photos for further details.

ABF personnel performing MT of Floor Beam (FB) to Side Panel (SP) weld joints; at FL3 area (Cross Beam area) from PP118 to PP120. On weld joint no: Seg3013AD-035 (PP120), at one location, toe crack was observed. This

was removed by grinding. Excavation depth was observed as 10mm approx. This QA Inspector informed about this to ZPMC QC, identified as Shen Jian Bo. ZPMC agreed that the repair welding will be done after having CWR for this location.

Repair welding of weld joint no: SP3103-001-085 (RS3349B stiffener to X4192B, CJP weld at PP118.35). The welder is identified as 069683 and was observed welding in the 4G position. Welding process was identified as SMAW. ZPMC QC was identified as Shen Jian Bo. The welding variables recorded by this QC appeared to comply with WPS: 345-SMAW-4G(4F)-FCM-Repair. Repair welding was done as per Welding repair Report (WRR): 20449 Rev-0.
